Department of Neighborhood Services Façade Report Application

Address of Building: 901 North 9th Street TaxKey 3910103110

Date of the Report: November 30th, 2016 Occupancy of Building: Assembly - Courthouse

Name: Todd A. Gorrell, R.A. Firm Name: Klein and Hoffman, Inc.

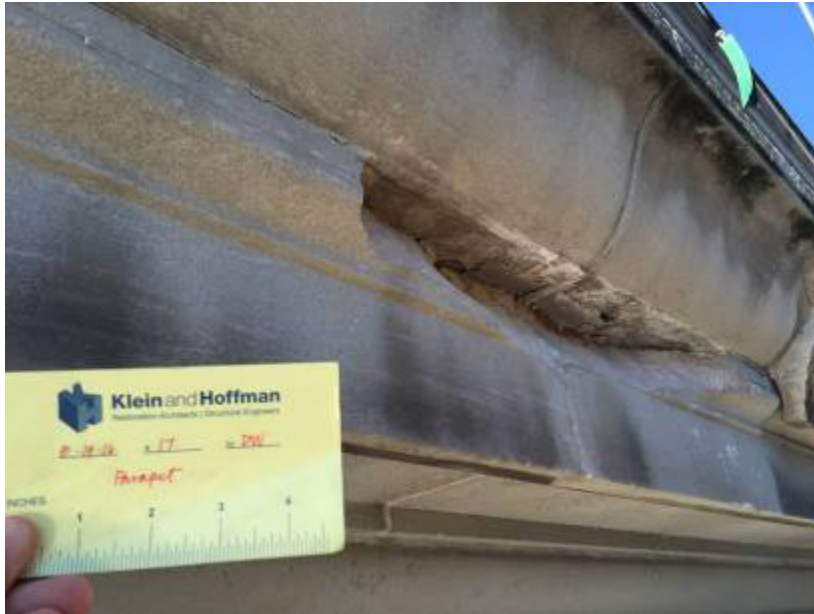
Photo No. 3 Spall removed at sixth floor cornice at drop no. 17.

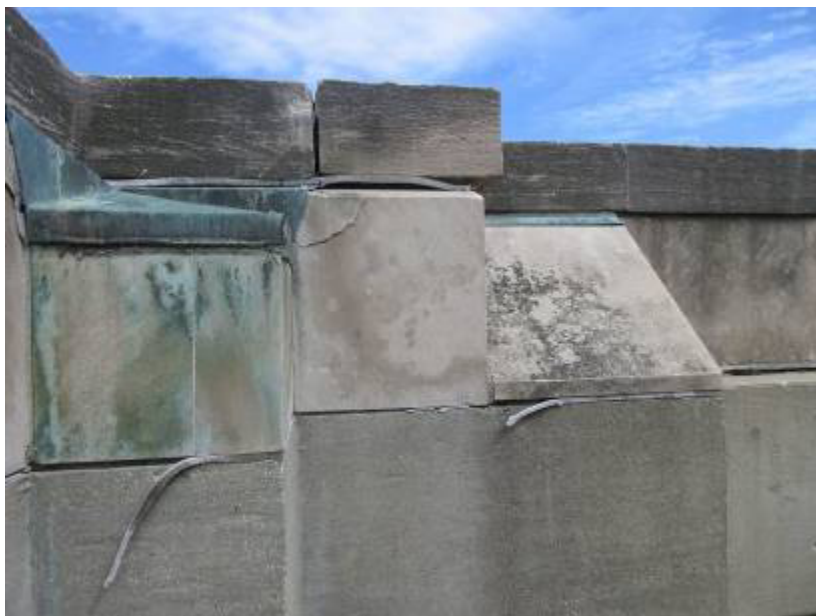
Photo No. 9 View of open joints and shifted masonry at northeast corner parapet.

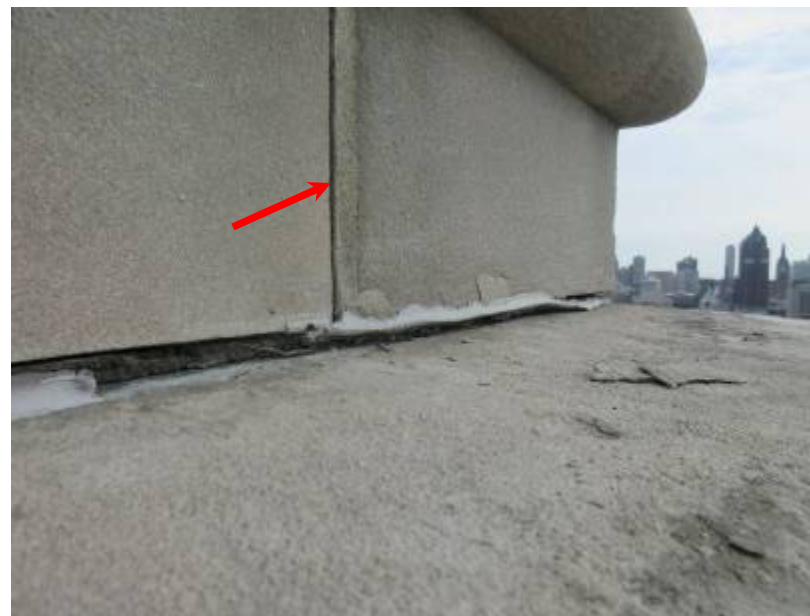
Photo No. 10 Slight displacement of cornice stone at the southeast corner of the eighth floor cornice is visible. Note failed horizontal sealant joint.

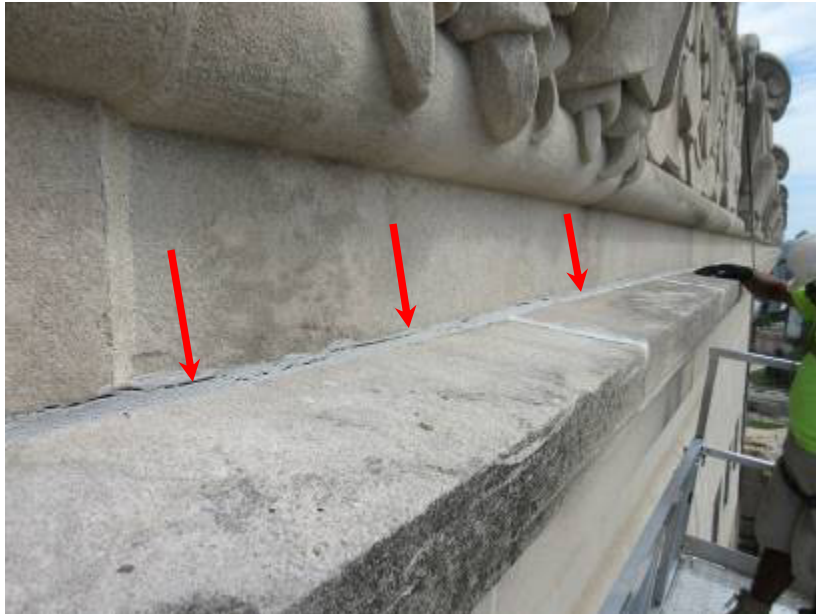
Photo No. 11 Sealed horizontal mortar joint at eighth floor cornice.

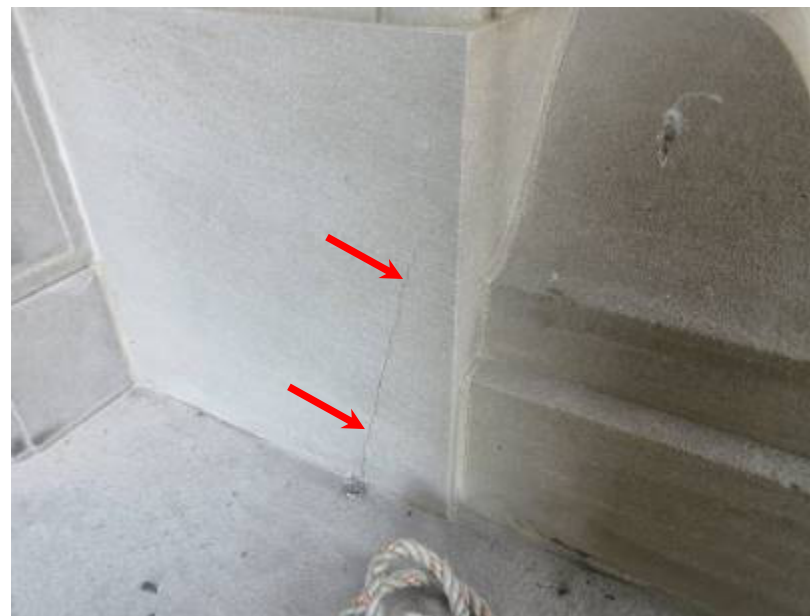
Photo No. 16 Cracked stone at return of ground level arcade.

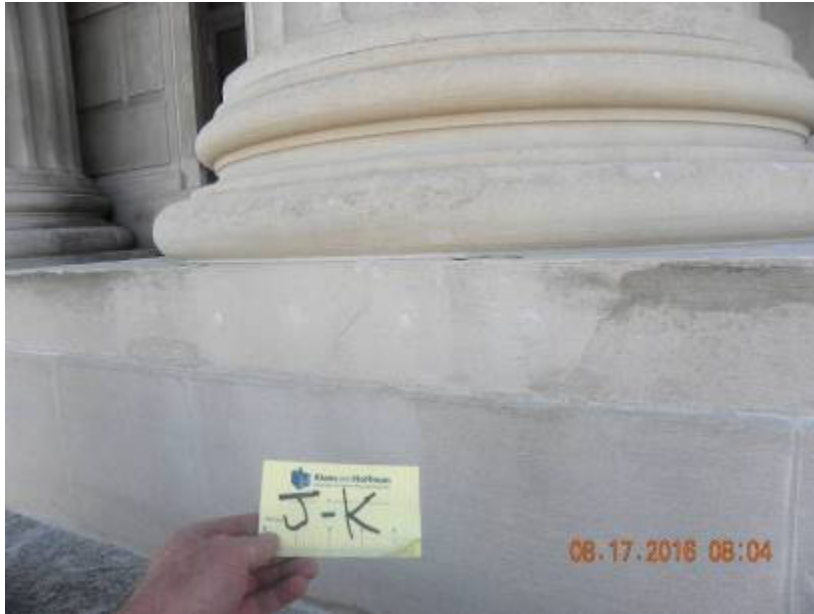
Photo No. 17 Cracked and delaminated previously applied patch on west elevation, J-K, was designated for removal during our inspections.

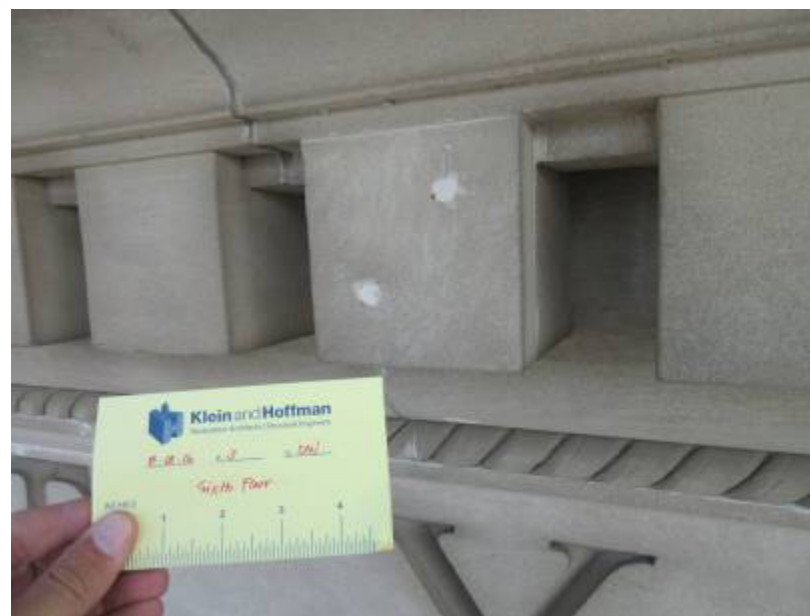
Photo No. 22 Previous pin and epoxy repair at a dentil at the sixth floor cornice at drop no. 3.

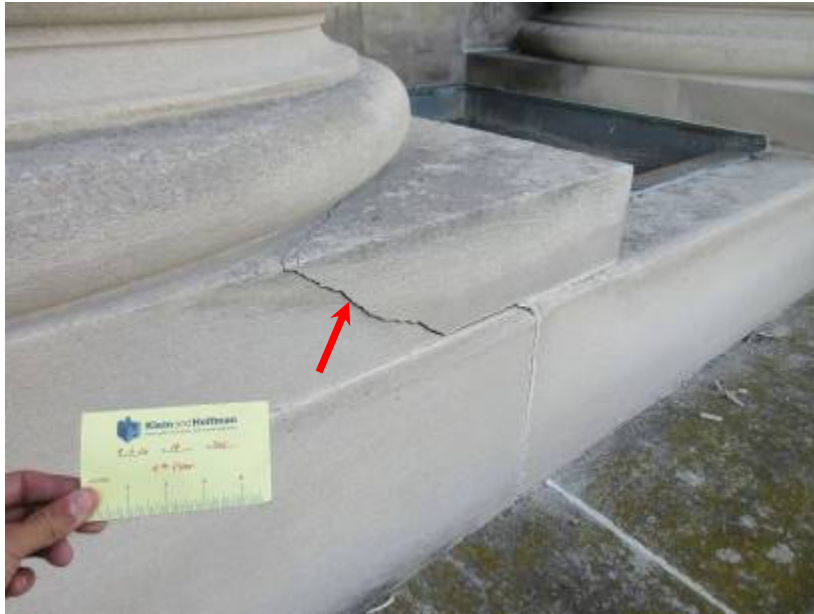
Photo No. 23 Cracked stone at the base of a column at drop no. 14.

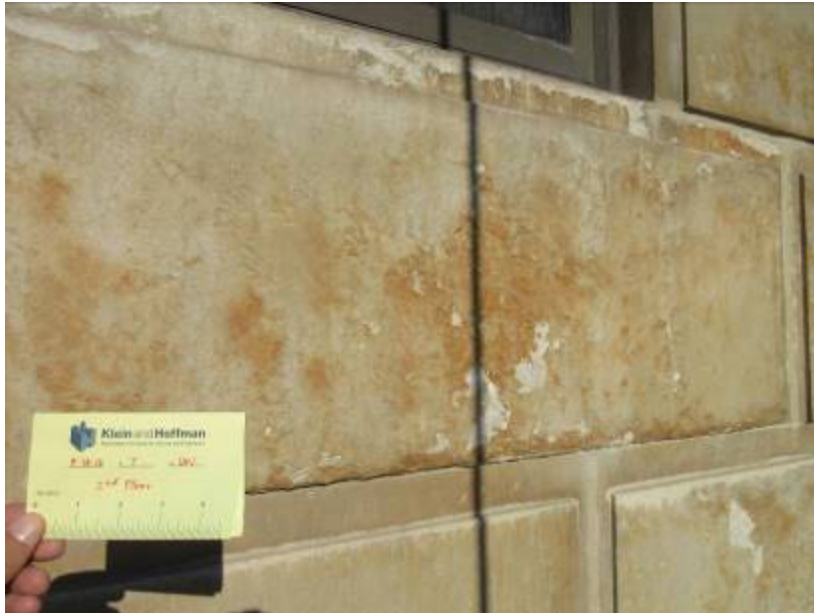
Photo No. 25 Widespread rust staining on the east elevation likely caused by cleaning chemicals reacting with the iron in the limestone.

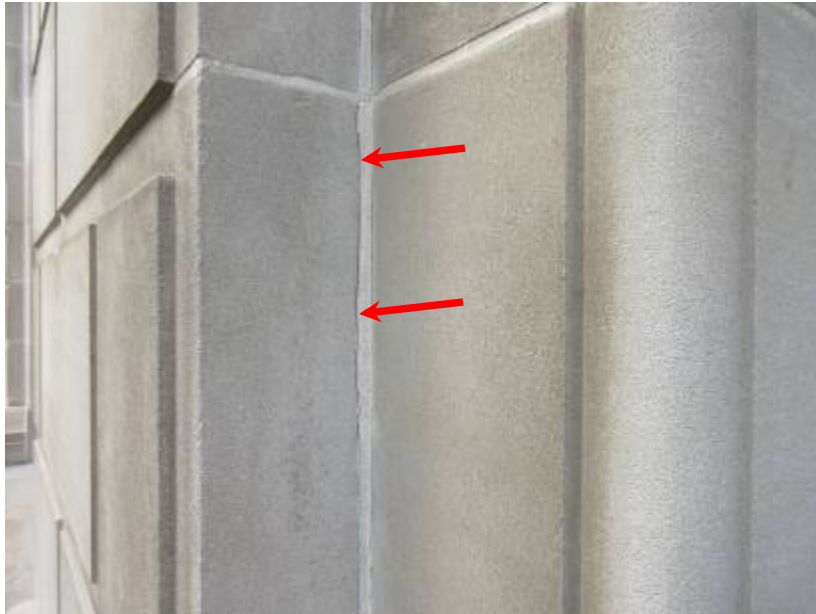
Photo No. 29 Failed mortar joint at corner of ground level arched opening at drop no. 16.

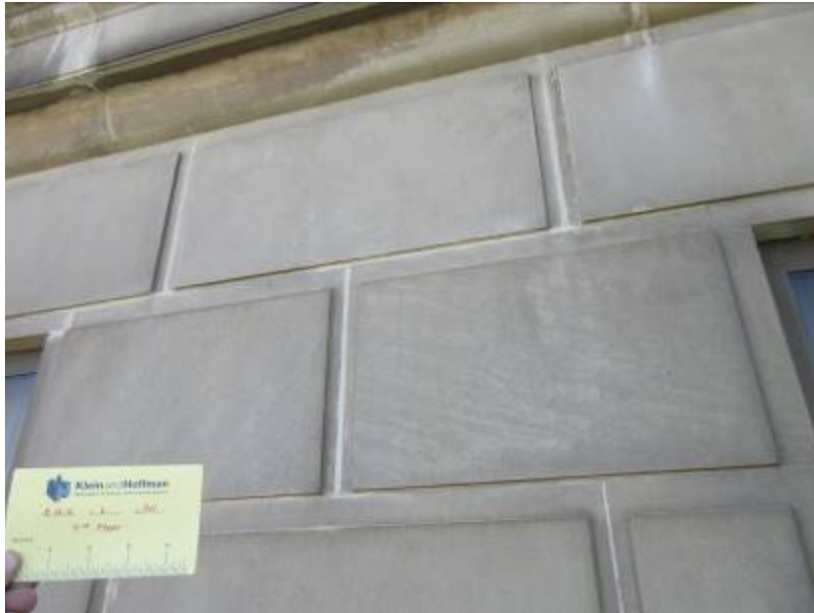
Photo No. 31 Fairly recently tuck pointed mortar joints do not match the existing mortar joints.

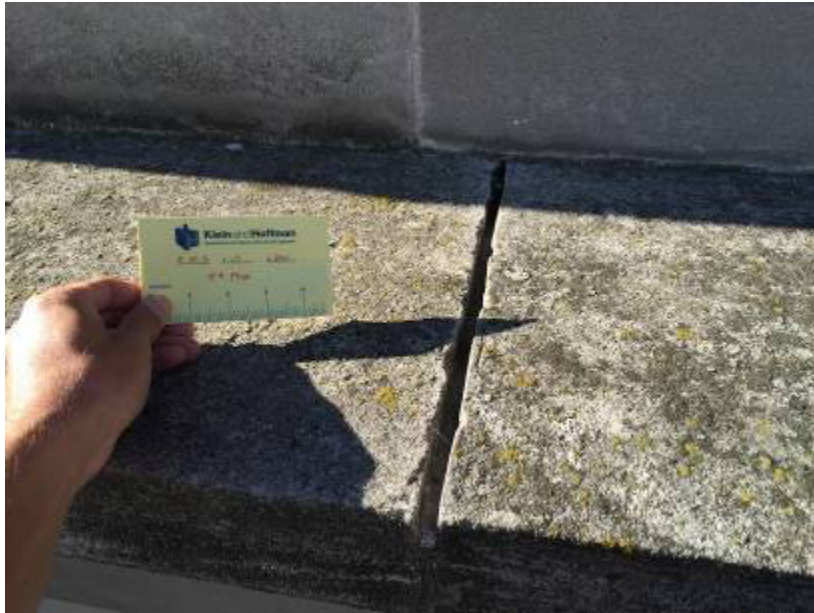
Photo No. 35 Missing sealant joint on 4th floor wash coursing on Drop #17.

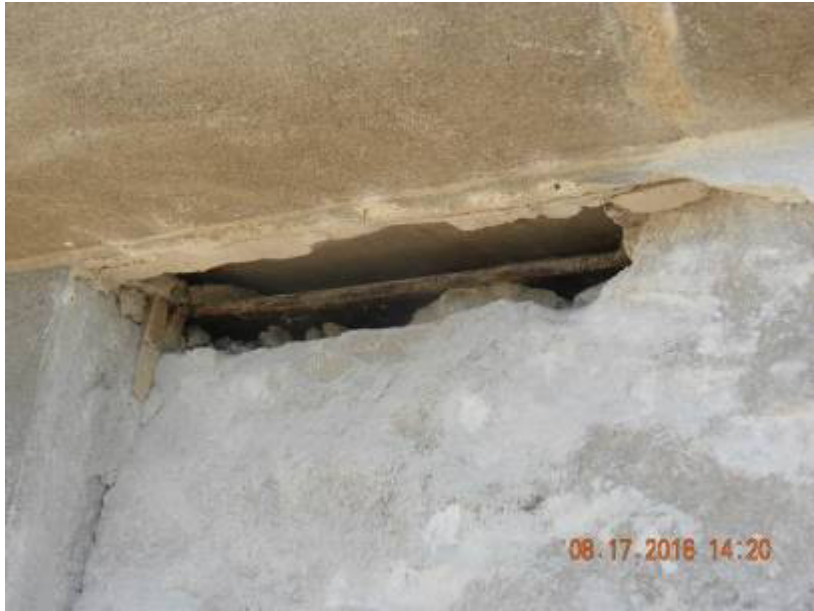
Photo No. 37 Close-up photo of embedded shelf angle above removed spall in previous photo. Lack of corrosion on the angle indicates that the spall was caused by moisture trapped in the wall during freeze/thaw cycles.

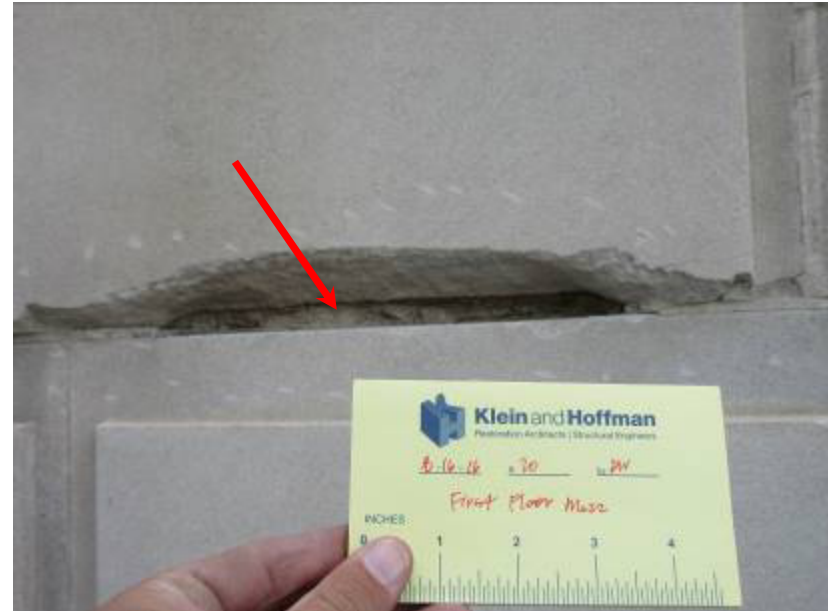
Photo No. 38 Spalled stone caused by corrosion on outer edge of embedded support angle at first floor, Drop 20.

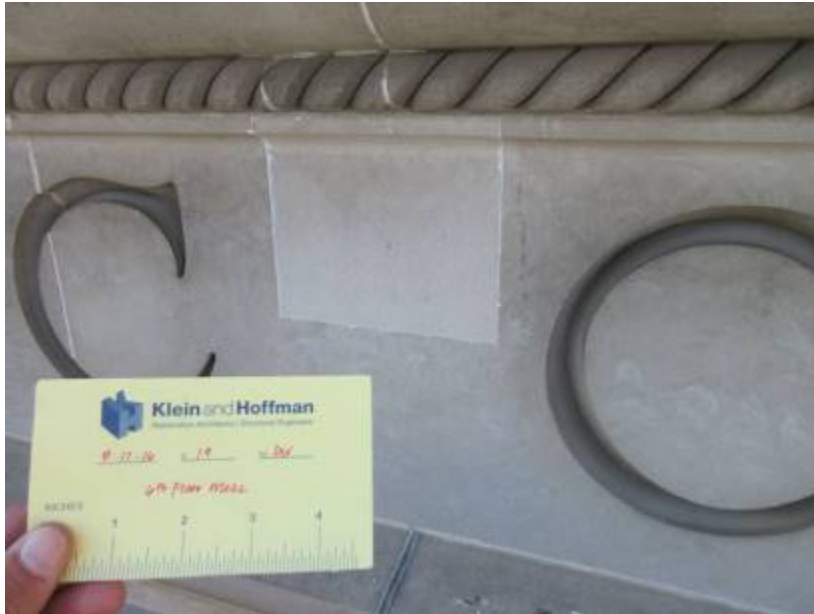
Photo No. 41 View of typical stone Dutchman repair.

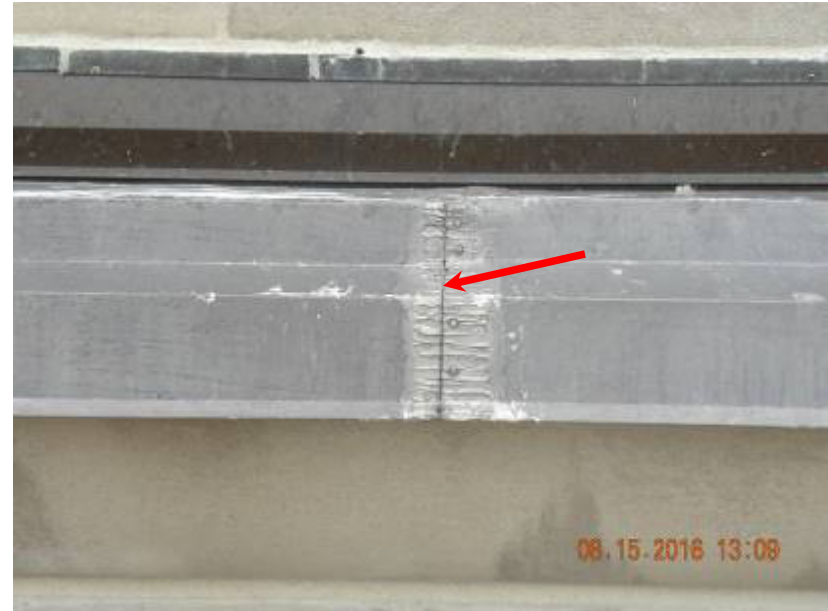
Photo No. 42 Open seam in side of gutter, E – F, west elevation.

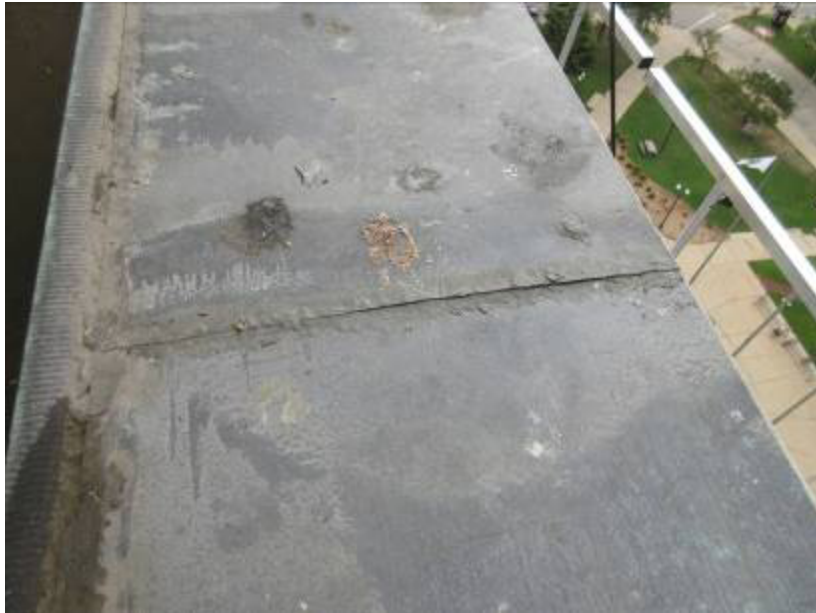
Photo No. 43 Open seam in top of gutter at Drop #1.

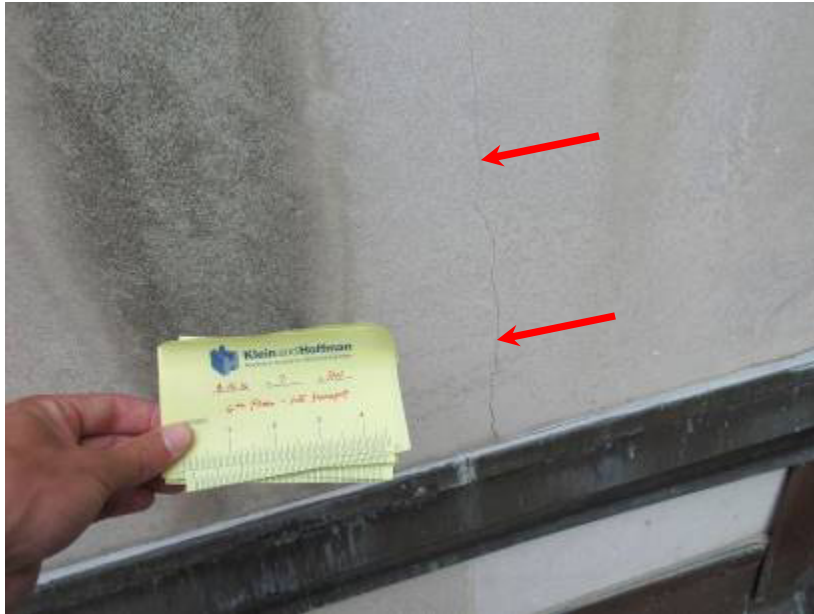
Photo No. 49 Small crack at sixth floor northeast parapet.

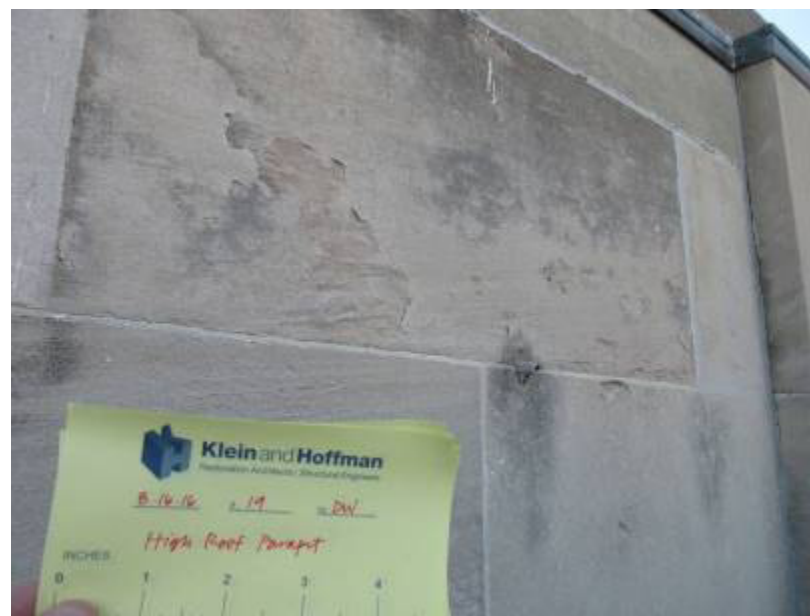
Photo no. 52 Showing weathered stone at high roof parapet.

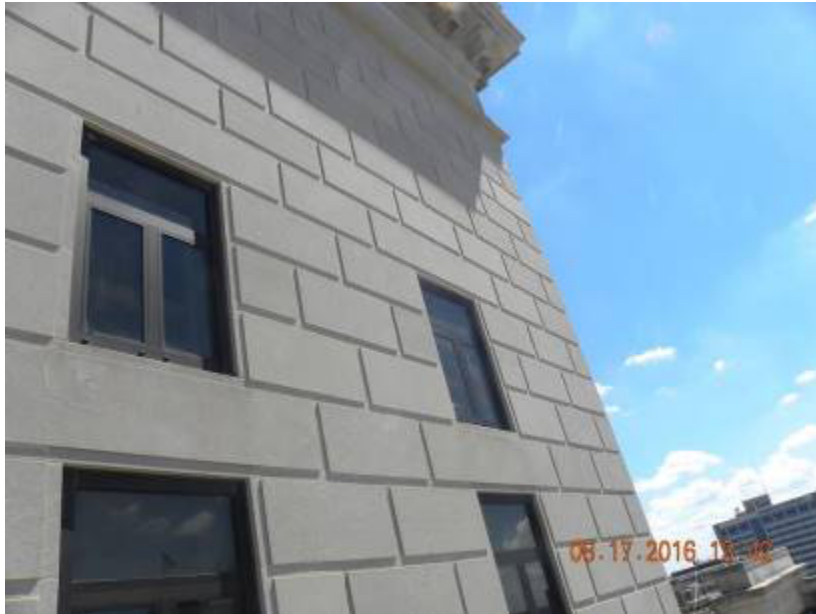
Photo No. 55 View of typical windows on the courthouse façades.

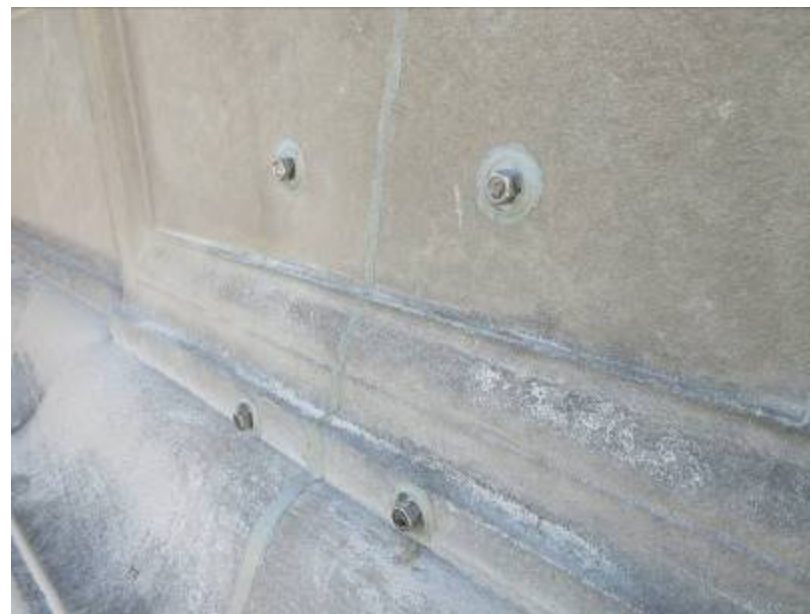
Photo No. 60 Stainless steel pins installed at cracked stones at the northeast sixth floor parapet.

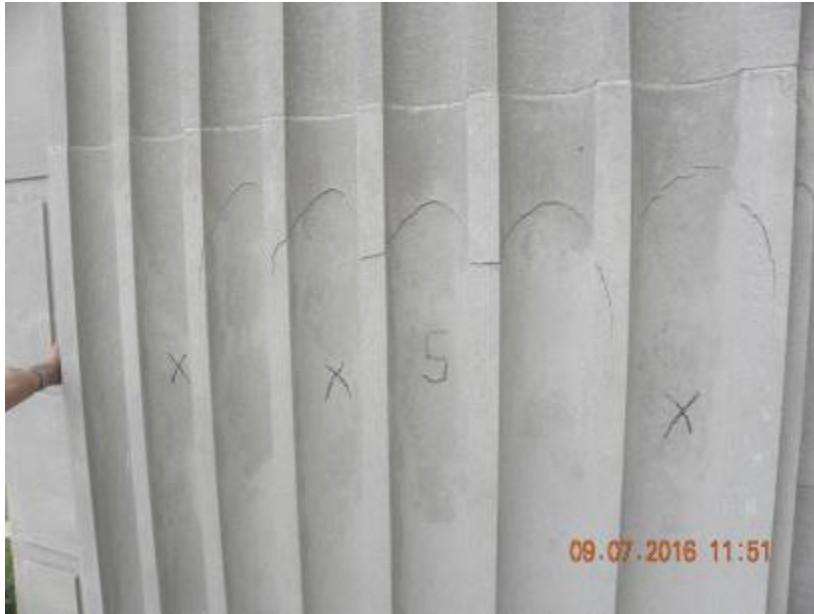
Photo No. 61 Spall to be removed. Black "X's" indicate specified locations for installation of pins.
